### Inspection Report

Subject: Woodford County

2625 County Road 600N El Paso, IL 61738 Longview Swine Farm, LLC

May 27, 2011

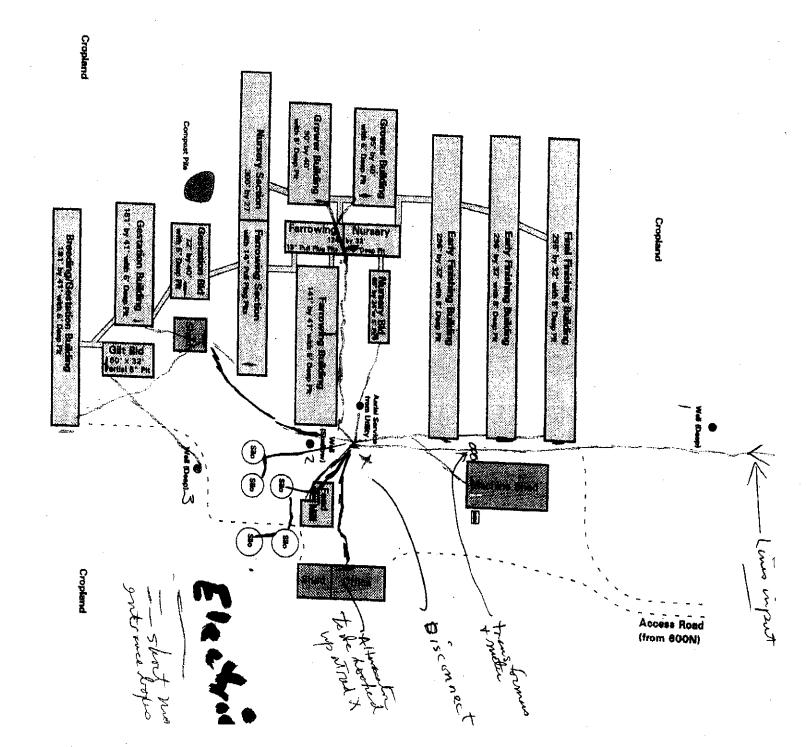
Figure 4. Plan View of Longview Swine Farm, LLC with locations of manure release and mortality compost area leachate

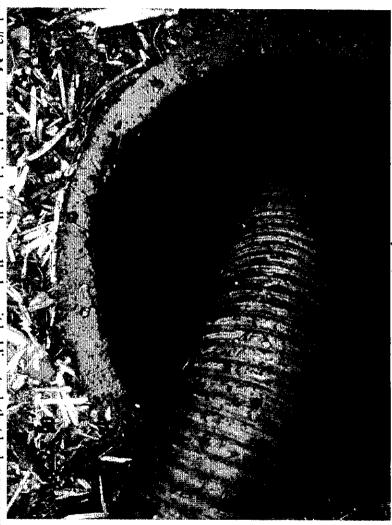
two shallow pull plug pits on-site.) The pump is used in emptying the manure holding tank have failed early the morning of the inspection due to foam forming inside the holding tank. manure from the tank is being pumped into other buildings' pits. This pump was reported to The manure holding tank can only hold  $\sim$ 84,000 gallons which is not enough and at this time the which is filled by the shallow manure collection pits under the Nursery/Farrowing Buildings. Building (See Figure 4) in the manure holding tank (this tank is only for manure storage of the manure release occurred because of a pump failing on the south side of the Nursery/Farrowing there did not appear to be evidence of the manure leaving the site. According to Mr. Bazer the recent manure release. During the inspection the manure was not witnessed leaving the site and At the time of the inspection this facility had many personnel working on the site, cleaning up a

Photograph #2. Location of the manure holding tank where manure release occured.

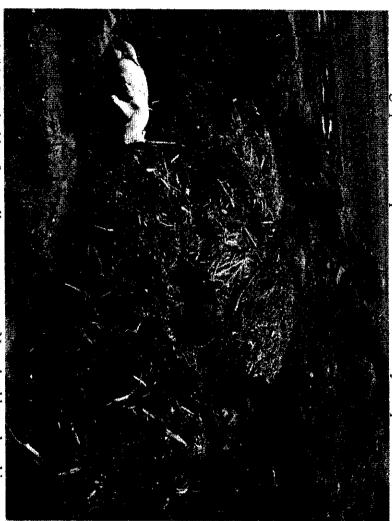
Photograp #5. Close-up of leachate from mortality compost area.

- capacity. Make sure the facility is watching the pits and transferring the manure when The manure pits need to be inspected to see where this facility is with the manure necessary.
- Ņ The mortality compost area needs to be inspected further to see if any leachate is leaving

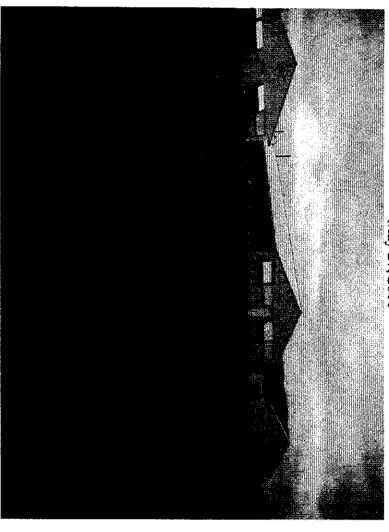
inspection there were also a few bones exposed. be seen that the leachate from the compost area is not being contained. At the time of the of the compost area. This facility did receive 2" of rain two days before the inspection, but it can As can be seen in Photographs #7-8 there is some pooling of water extending from the west side

Photograph #8. Mortality compost area leachate puddles to the west. View is south.
